TROUBLE TRACER CHART

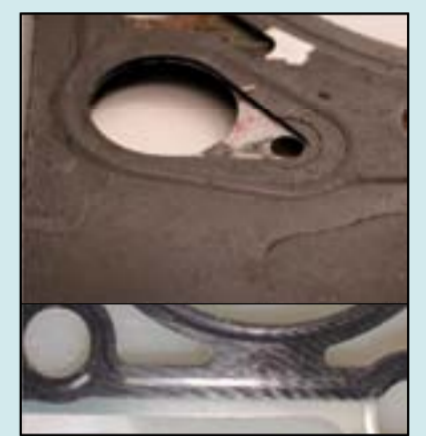
SURFACE FINISH

Recommendations: To ensure an effective seal between the cylinder head gasket and the joint face is obtained, the surface finish of the cylinder head must be taken into consideration. Too smooth a finish may allow gasket movement, resulting in failure. Too rough a finish will prevent adequate surface sealing between the gasket and the engine surfaces, allowing seepage to occur. The table below gives the approximate surface finish requirements in micromillimetres from the various types of gasket available. These are general guidelines but should be used when alternative OE specifications are unavailable.

Surface Feature	Gasket Type			
	Fibre	Graphite	Multi-Layer Steel	Steel-Elastomer
Maximum Roughness Rz (Sampling Length)	12µm - 15µm (0.80mm)	12µm - 15µm (0.80mm)	< 12.5µm Depending on Coating thickness (0.80mm)	12µm - 15 µm (0.80mm)
Waviness Wt (Sampling Length)	< 10µm (2.5mm)	< 10µm (2.5mm)	< 10µm (2.5mm)	< 10µm (2.5mm)
Flatness	50µm over 150 mm	50 µm over 150 mm	<25µm over 150 mm <25µm overall	50 µm over 150 mm

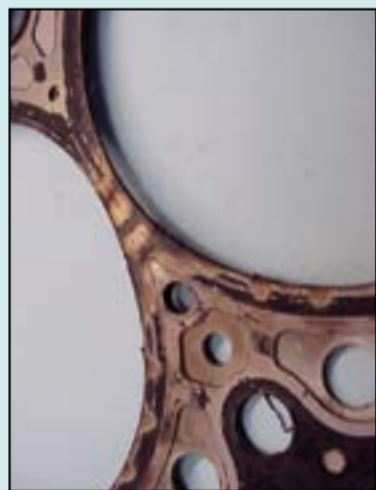
OVERHEATING

Symptom: Gasket materials are hard and carbonised. Surface cracks are evident. Bore eyelets are discoloured.

Cause: Overheating causes hardening of the gasket materials and possible material degradation. This will reduce the sealing effectiveness of the gasket.

Remedy: Maintain cooling systems in good order. Rectify leaks immediately. Replace cylinder head gasket if engine has been severely overheated. A planned repair is better than an unexpected failure.

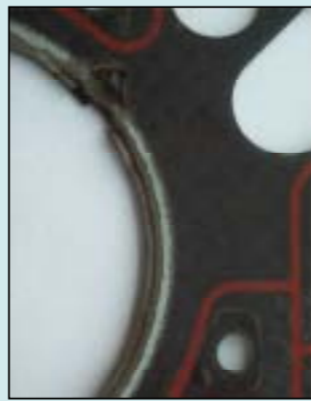
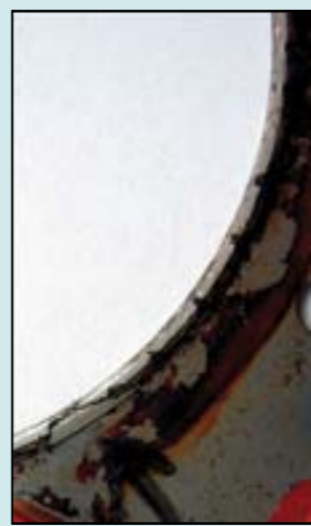
ABNORMAL COMBUSTION

Symptom: Gasket material is burnt away, often between cylinders, or at a location where detonation or pre-ignition occurs. Discolourations are indicative of elevated temperatures around the bore eyelets and combustion gas leakage paths are evident.

Cause: Detonation and pre-ignition increase the localised surface temperatures in the combustion chamber and damage the gasket by burning away the gasket material. In addition, the excessive cylinder pressures are generated which counteract the clamping load leading to a fatigue failure of the gasket bore seal.

Remedy: Keep the ignition system in good order. Ensure the spark plugs have both the correct heat rating and electrode gap. Use the correct grade of fuel specified for the engine and check the compression ratio if major engine machining operations have been undertaken.

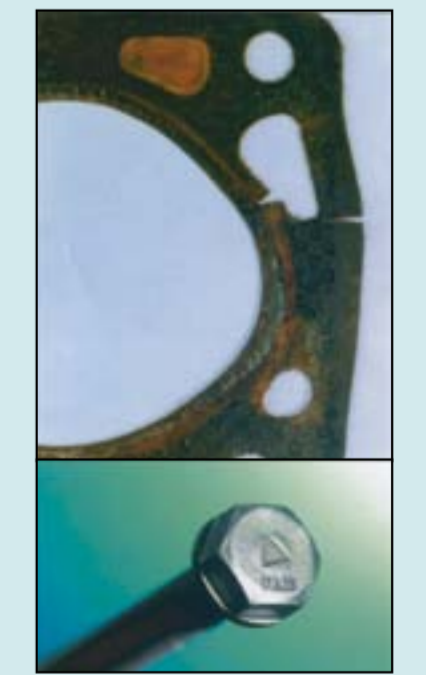
RETORQUE OMITTED

Symptom: Displacement of the gasket material and cracking of the bore eyelets due the clamping force reduction. Leakage occurs within the first few thousand miles.

Cause: Depending upon the type of material and construction, some cylinder head gaskets settle slightly when exposed to heat and vibration. If the cylinder head bolts are not retorqued after an initial period of engine operation, the clamping load is reduced and leakage occurs.

Remedy: Always follow the manufacturers' instructions about retorquing cylinder head bolts after a specified mileage. If the engine is to pass out of your control, clearly label it that a retorquer will be required.
